COATING OF WEAPON COMPONENTS WITH BEARING MATERIAL (Phase 1)

M.SOLANKI

DECEMBER 1980

TECHNICAL REPORT

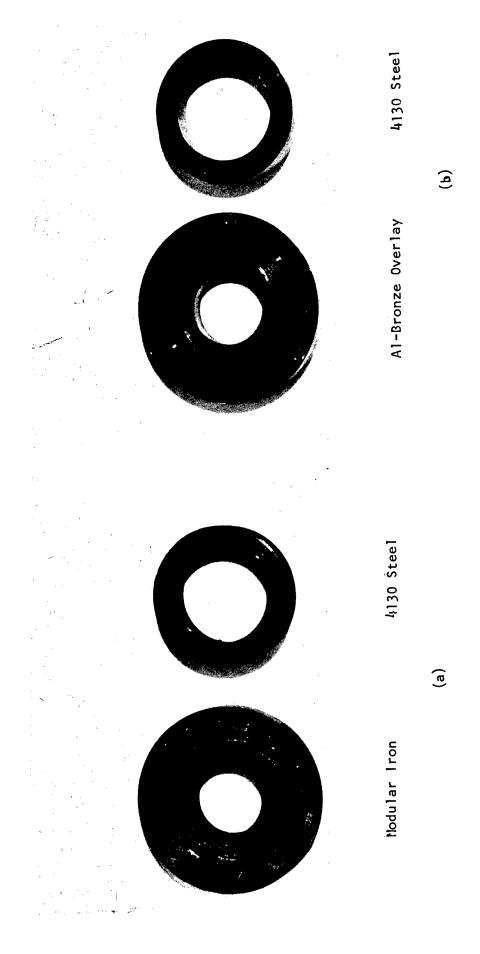
Under all experimental conditions used, the co-efficient of friction for Al-Bronze is twice that of nodular iron (see Results, Table 3). It was observed that for the shorter time duration test (1 min.), nodular iron shows less wear than Al-Bronze. But for the one hour test at higher load (1500 lbs), the nodular iron surface and mating steel surface experienced severe galling (Figure 2a), whereas under the same experimental conditions the Al-Bronze surface revealed medium galling (Figure 2b). A possible explanation for this is that under higher loads for long time, graphite particles imbedded in the nodular iron matrix are gradually eroded from the surface causing the material to lose its natural lubricity.

FIGURE 2. SHOWING WEAR ON SURFACES AFTER ONE-HOUR TESTS. (a) NODULAR IRON VS. STEEL (b) AL- BRONZE OVERLAY VS. STEEL

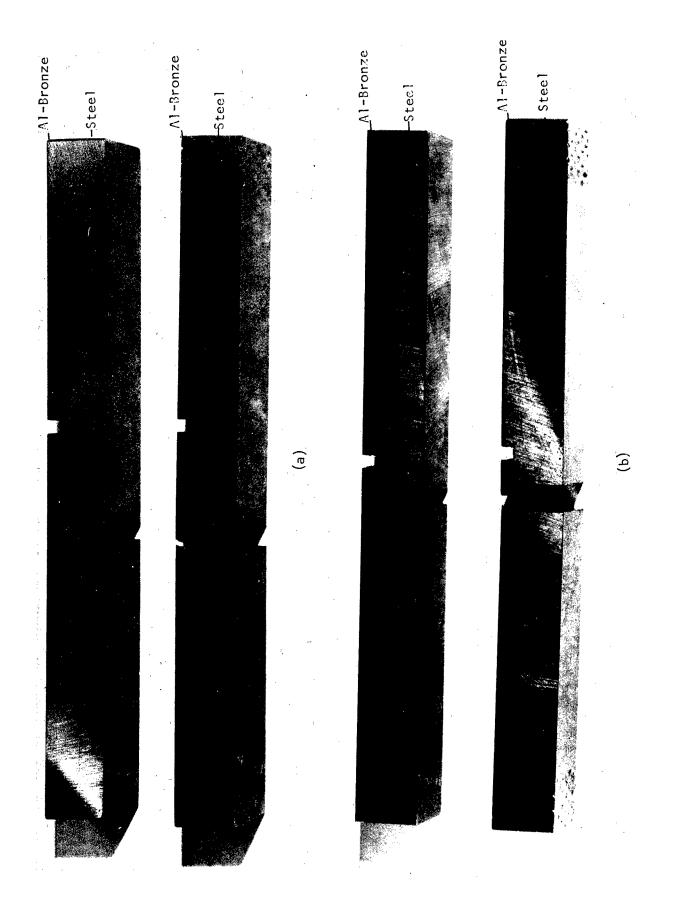
2.4.2 Results: In all the tests, failure occurred through the clad material in Figure 4. Measured tensile strengths were between 75 to 94 KSI. This indicates that the bond strength in shear is much higher than the tensile strength of bearing material.

FIGURE 4. SPECIMENS BEFORE AND AFTER TESTS - (a) TENSILE TEST; (b) SHEAR TEST

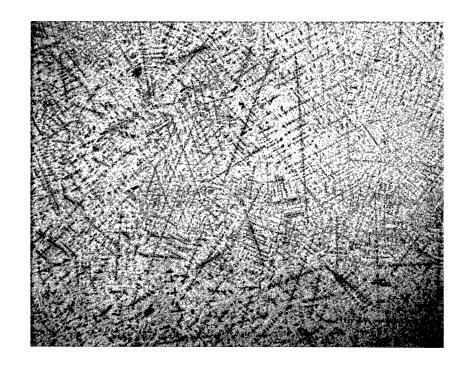
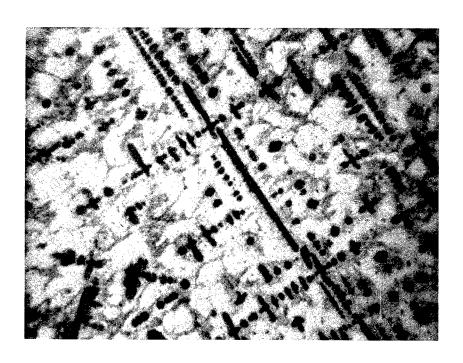
The microstructures of weld deposits on the test plate are shown in Figures 5a and 5b. In Figure 5a, a columnar dendritic freezing pattern is evident in the copper-base weld. Crystals grew with a preferred orientation and the dendrite direction is parallel to the direction of heat flow. The gray interdendrite phase may be untransformed beta (Al Cu₃). This phase is retained on rapid cooling of the weld alloy. Such a structure is typical of as-cast copper alloys and is not harmful. No iron-rich phases were detected using the Scanning Electron Microscope. Nominal number of shrinkage cracks were discovered, depths ranging from 0.003 in. to 0.010 in. Since the weld alloy completely filled and bonded these cracks, they were judged to have produced no harmful effects.

FIGURE 5. MICROGRAPHS SHOWING COPPER-RICH DENDRITES IN A1-BRONZE OVERLAY. MAG.: a. 100X b. 800X, ETCHANT: NH₄OH - H₂O₂ (1:1)

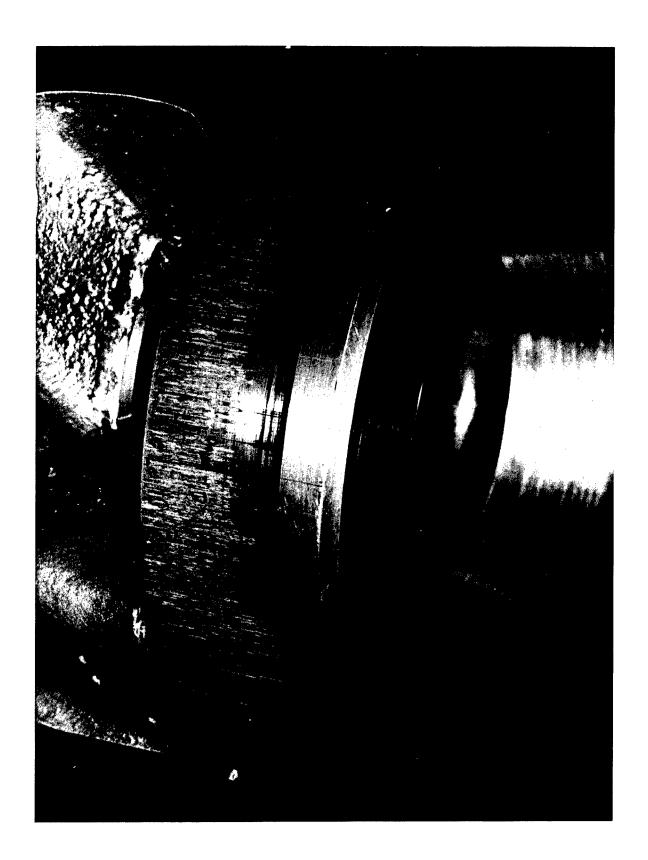
Bearing surfaces of the I.D. and O.D. of the piston were lightly scored as shown in Figures 12 and 13. This was mainly due to abrasion of hard chromium particles which were chipped off from chromium plated surface of the cylinder. Overall performance of Al-Bronze as bearing material was considered good. Figure 14 reveals few linear scratches on inner surface of cylinder.

FIGURE 12. LIGHT SCORING ON OUTER BEARING SURFACE OF M174 PISTON AFTER TEST FIRING.

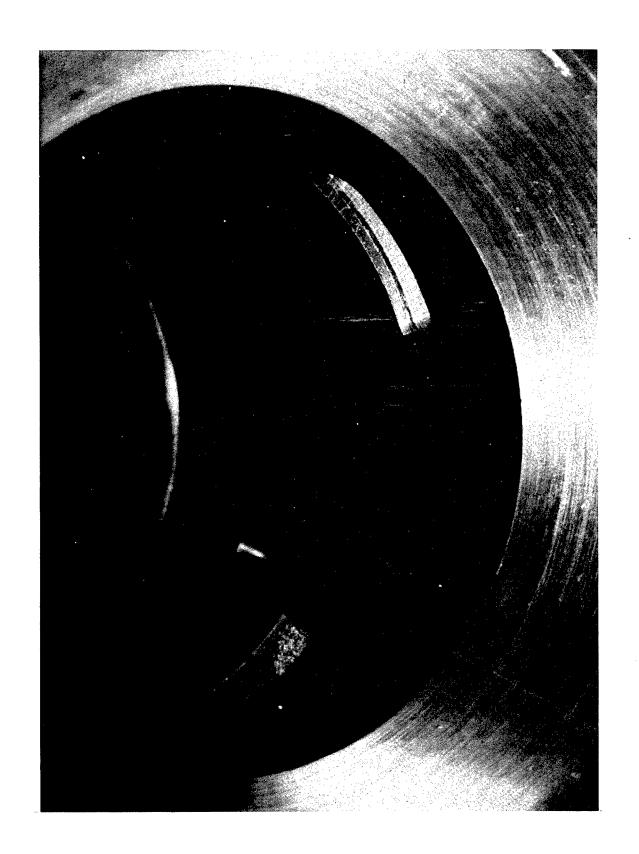
FIGURE 13. LIGHT SCORING ON INNER BEARING SURFACE OF M174 PISTON AFTER TEST FIRING.

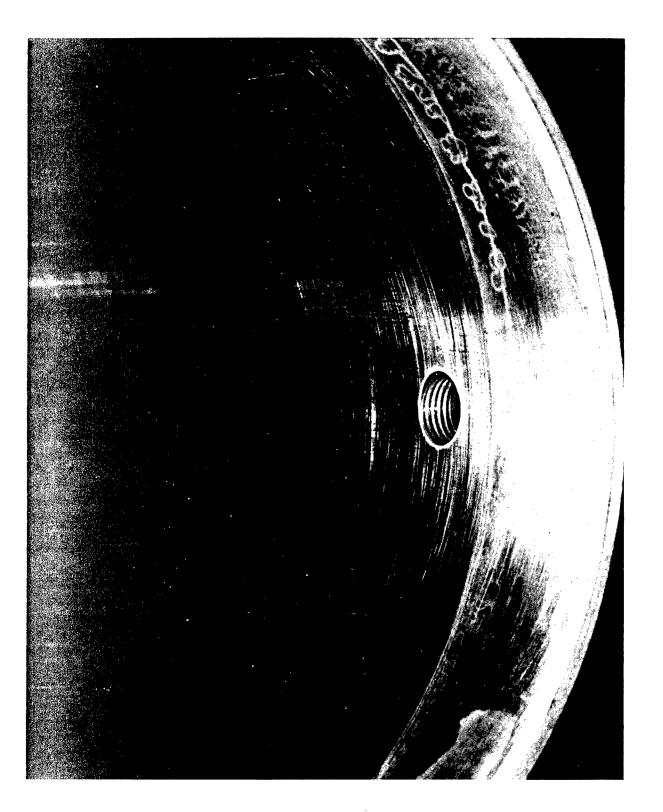
FIGURE 14. LINEAR SCRATCHES ON CHROMIUM PLATED SURFACE OF RECOIL CYLINDER AFTER TEST FIRING,
